# Manhole Inspection Summary

Manhole # **S35C\_\_071MH**

Insp Date: **8/10/09 6:57 PM**

**Location** Address: **112 N. Calvert St**

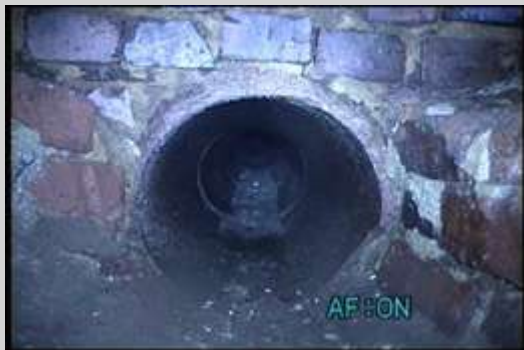
12 O'Clock Outflow

12 in. Circular Gravity Sewer  
Pipe Out @ 12 OClock

Pipe Height: **12** (in.) Rod and Bar (Angled)  
Pipe Material: **Clay** ☐ Pipe Lined  
Invert Depth: **14.58** (ft.) Flow Characteristics: **None**  
Deposits: ☒ None ☐ Mud ☐ Sludge ☐ Debris ☐ Grease  
Silt Depth: **0** (in.) Deposits Extent:  
Infiltration: **None** Pipe Seal Cond: **Sound**
